FACTUAL REPORT

Duty Holder Details: Paul Christopher Building Limited

1. Numbers 2-3, Durham Place, London, SW3 4ET are part of a terrace of 6 houses, originally built in the early 1700's. Over the years, numbers 2 and 3, and, 5 and 6, have been knocked through and converted into single dwellings. The photograph below is taken from Google Streetview, showing the terrace in March 2019. House number 1 is at the left hand side.
2. Starting from the left hand end, the 4th – 7th windows are numbers 2 and 3. As well as the floors seen in the photograph, there is a lower ground floor to the terrace, as the gardens at the rear of the terrace are lower than the ground level at the front.

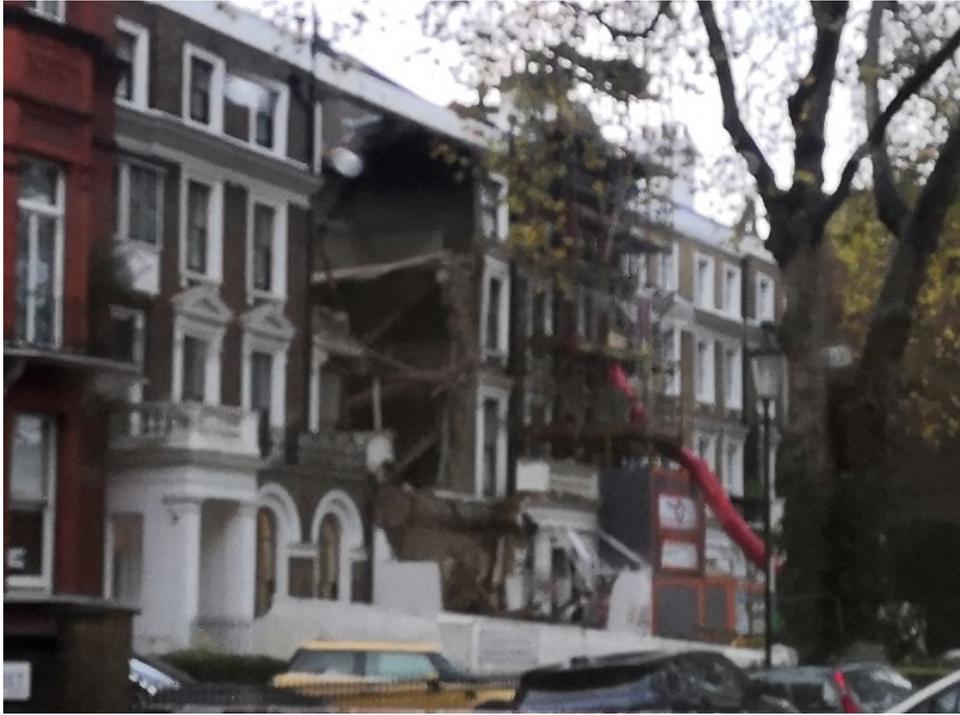
11. At approximately 23:30 that evening, the building started to collapse, initially with the front walls, as shown in the photographs below, taken at approximately 7 AM and 20 minutes later.
